Team name: Knights Experimental Rocketry

1.2 Purpose of Flight

2 Payload Demonstration Flight Results (If applicable)

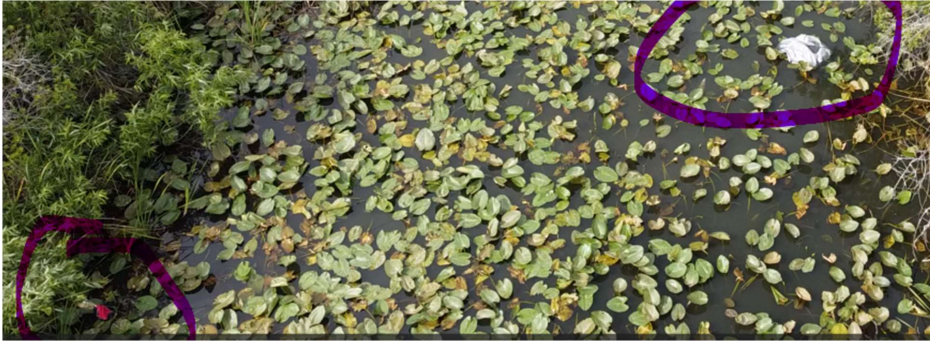
However, whilst testing corroborated our capacity to do this, the rocket's unfortunate landing in a canal prevented us from observing these results directly after flight.

Main (Top Left) Drogue (Bottom Right) Payload (Submerged)

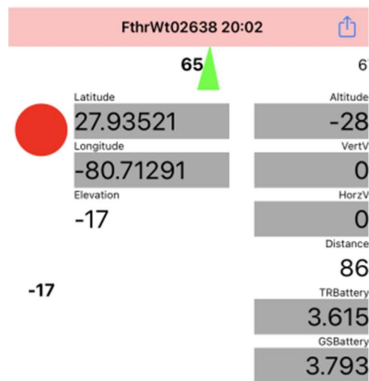
Coordinates of Asclepius at 3:53pm, 3/18

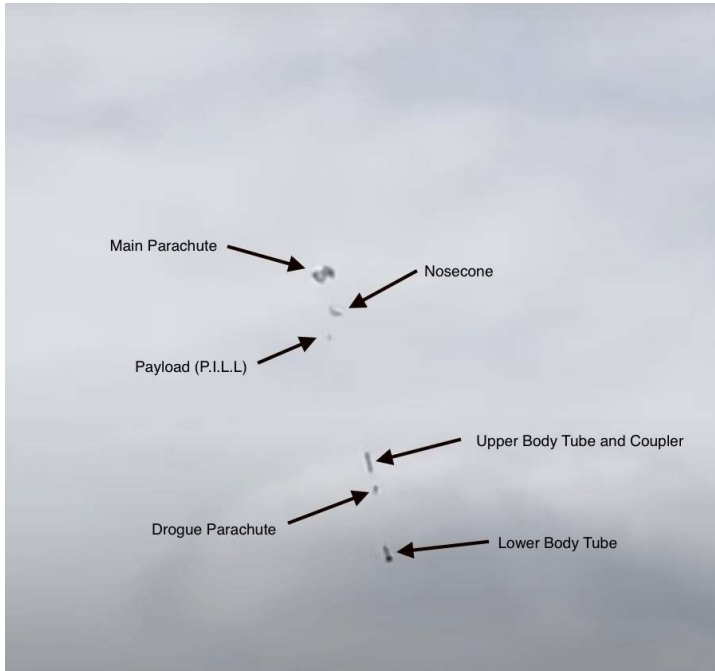
Asclepius descending under Main Parachute

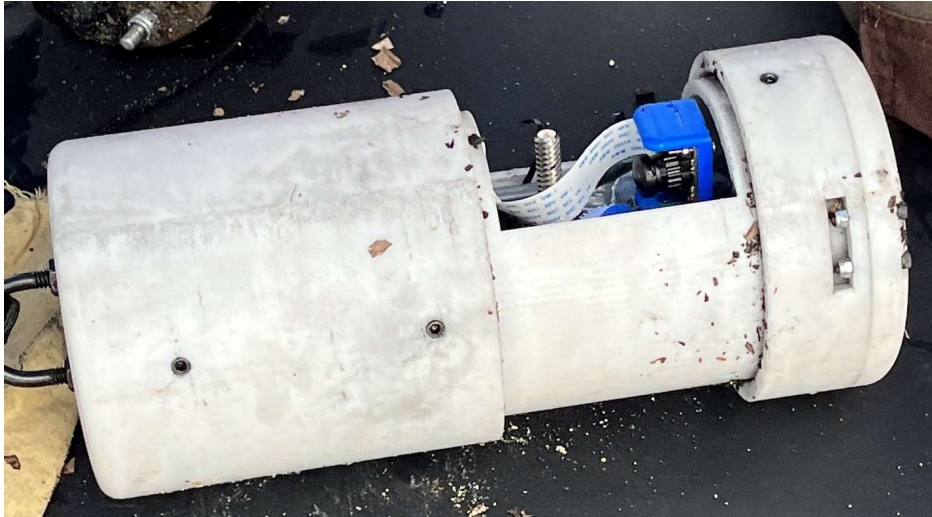
Payload After Launch

From the limited data we were able to salvage, we can say with confidence that our descent velocities were safe and were it for not the landing in water, the Experiment would of most definitely been unharmed. In fact, besides the electronics, the physical components of the Payload were undamaged – besides dirt from the canal staining the outer casing.

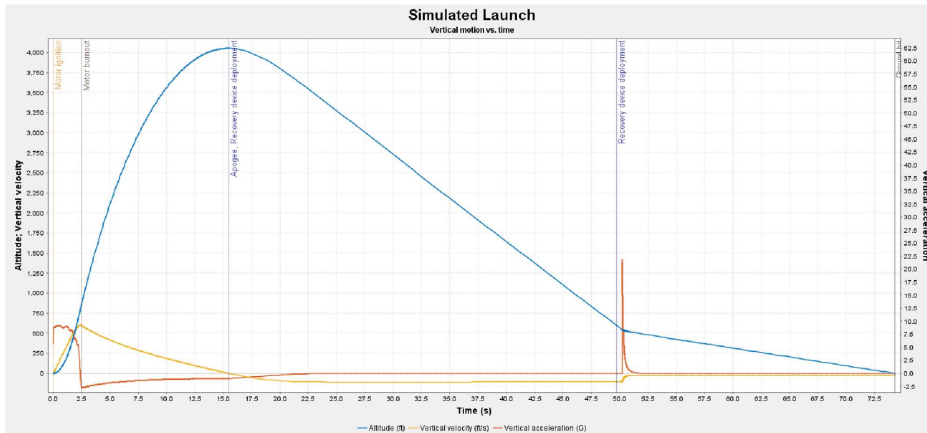
Above is the simulation ran on launch day to predict what our apogee was going to be given the current conditions. The simulation said our apogee was going to be 4044 feet. Our actual apogee ended up being 4088 feet based off of the RRC2+ flight computer. Sadly we have no way of getting any of the flight graphs off of the altimeters due to them being submerged in the water for over 45 minutes while we searched through dense bushes in order to find the rocket. We used our featherweight to give us the general location since we had the last known location of the rocket before it died, it led us close to the actual location, but we had to use a drone in order to find the rocket due to the bushes being thick the side of the canal we were at the time. While the rocket was under drogue we heard descent velocity callouts from the featherweight and the descents ranged anywhere from 75 ft/sec to a maximum of 97 ft/sec. The descent velocity that OpenRocket gave us under drogue was 106 ft/sec. All though we do not have our descent velocity under our main parachute, OpenRocket said the ground hit velocity is at 22 ft/sec and we are confident that the true ground hit will be around 22 ft/sec due to how closely the data we were able to get matched up with the OpenRocket simulation.
