University of Central Florida – 2023 – PLAR – Report 4000 Central Florida Blvd, Orlando, FL 32816 Knights of Experimental Rocketry 04/19/2023

1.7 Competition launch flight profile data.

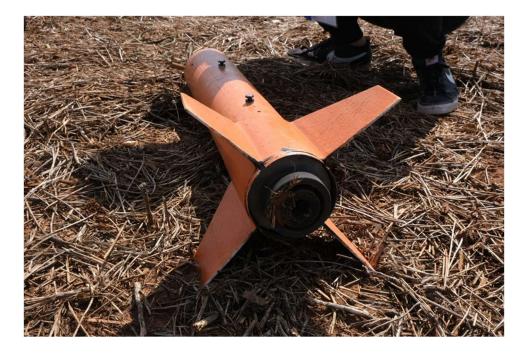
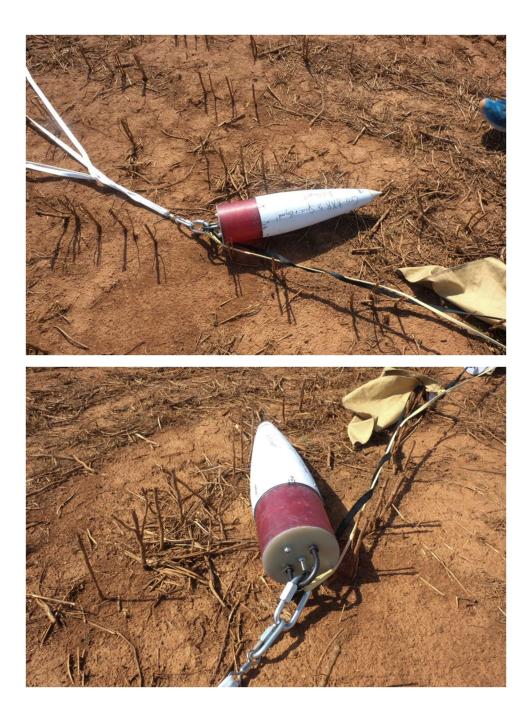
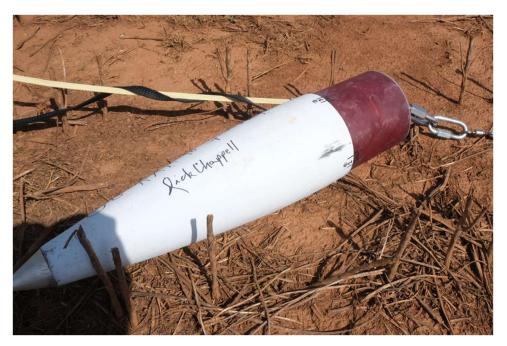
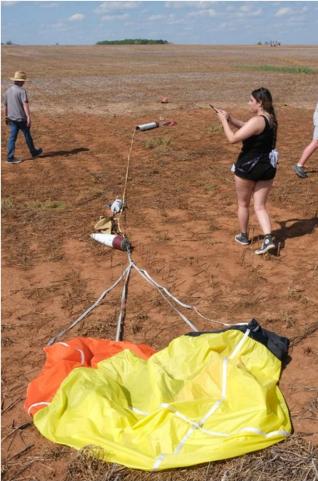
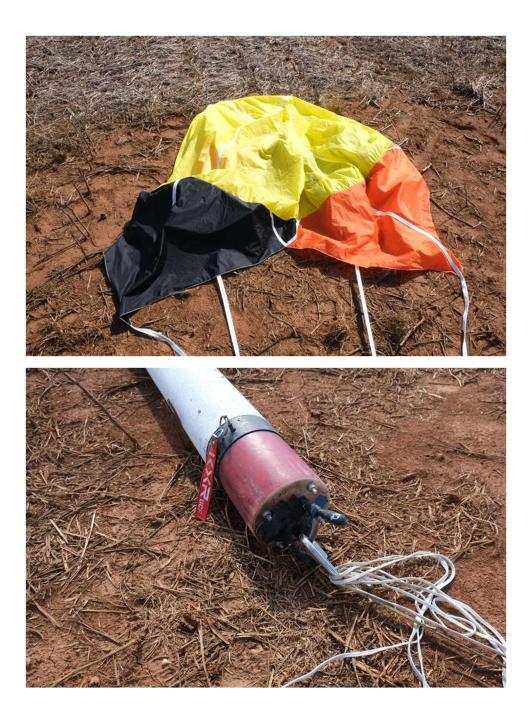
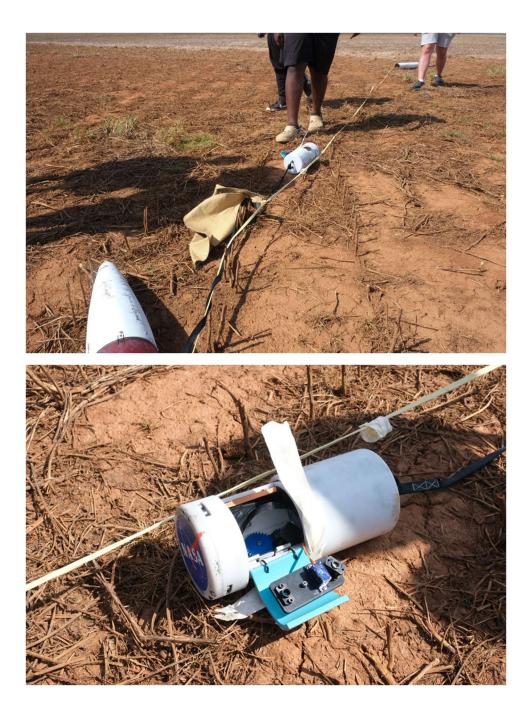
Looking at our data, we can see that there was an event at apogee which is when our drogue and our main parachute deployed simultaneously. We believe the cause of this to be the packing volume limit had been reached with our switch in parachutes leading to extra force on the shear pins. When the drogue charges went off in flight, we believe that the force from the charges sheared both the drogue shear pins as well as the main shear pins. After flight, our rocket recovered safely with minor scuffs on the outside of the airframe. Both parachutes were checked for holes, and none were found. On the recovery coupler, one of the main charges didn't go off. We replaced the recovery pin and removed the charge safely. Our payload had successfully deployed; however, the inner camera mount of the payload had broken upon impact.

After liftoff, the primary altimeter set off the drogue charges approximately 15.4 seconds after launch at an apogee of 3917 ft AGL. However, at this point the nosecone was displaced from its launch position at apogee due to the sheer bolts being sheered from the compression of the main parachute and the shock wavs of the drogue charges.

Despite that, the redundant charge went off approximately 1 second after the drogue charge as programmed. The main parachute deployed 20 seconds later at an altitude of 2577 ft AGL. Both main primary and main redundant were set off at 600 ft AGL as programmed.

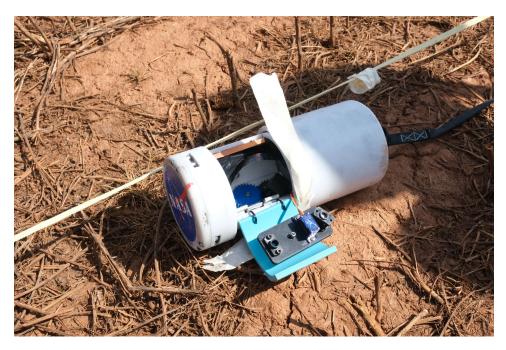
- **Camera Deployment:** While troubleshooting the issues with our radio, one of the two lead screws used in our deployment mechanism broke off. We attempted to repair it, but reinstalling it was causing further problems and we were very close to our designated launch time. The decision was made to launch with only a single lead screw, which was still capable of pushing open the hatch. However, upon landing the lack of both lead screws caused the entire linear elevator mechanism to fall apart, as seen in the above photo.
